CONDITION SURVEY, LIBBY ARMY AIRFIELD FT. HUACHUCA, ARIZONA

April 1971

Conducted by U. S. Army Engineer Waterways Experiment Station, Vicksburg, Mississippi

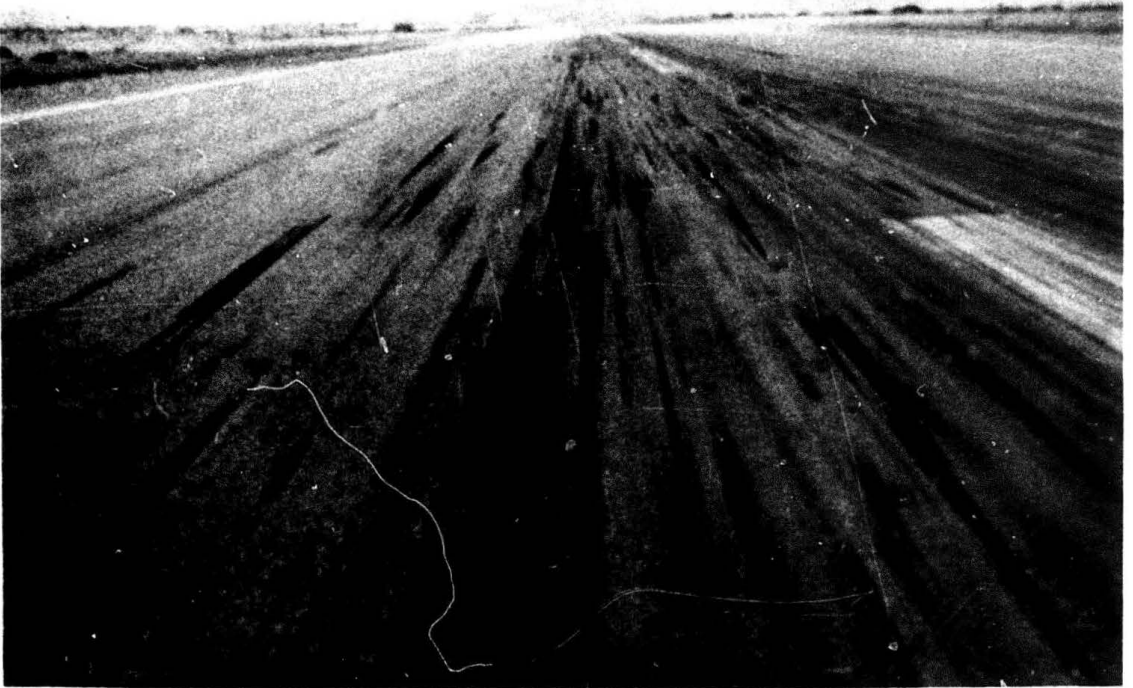
10. A visual inspection of the pavements in September 1970 indicated the pavement condition to range from poor to excellent. The sand seal placed on the primary runway in 1969 appeared to be in good condition on both the runway and shoulder areas (photographs 1-3). There was no evidence of any scuffing of the sand seal where aircraft had made 180-deg turns on the runway. There were two areas on the runway that contained birdbaths (photographs 2 and 4) and a depression from a drainage structure about midway of the runway. There was evidence of a few areas of longitudinal shrinkage cracking, but in general the runway condition was considered good. The surface of the crosswind runway, which was sand sealed in 1968, was considered to be in good

Photograph 1. View to northwest near southeast end of primary runway

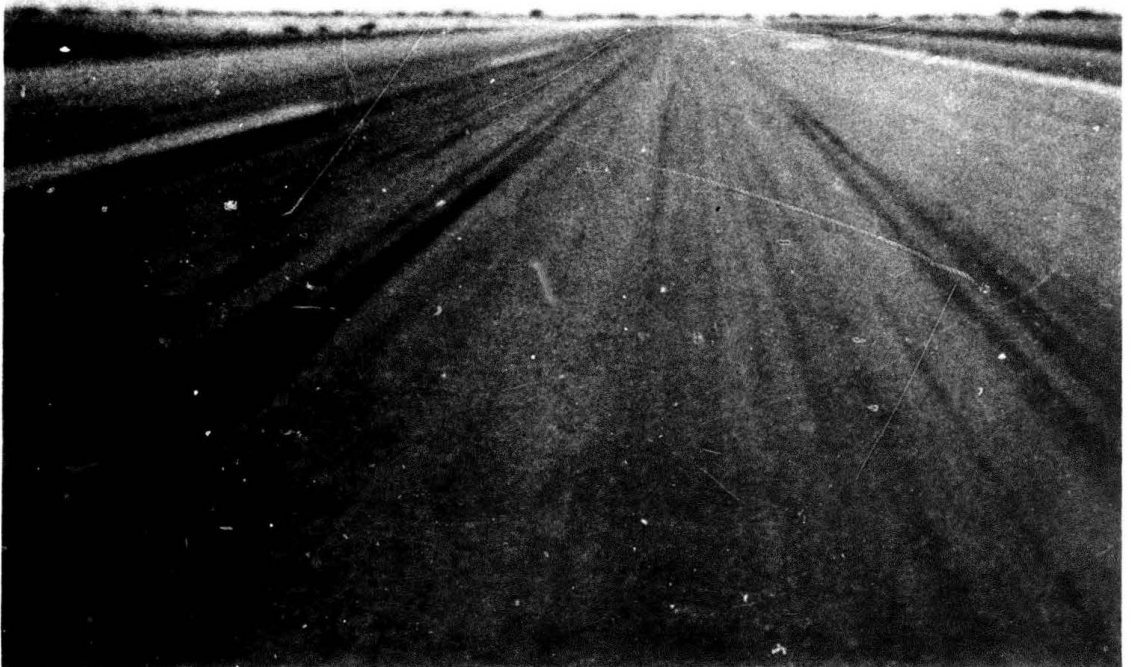
Photograph 2. View to northwest near center of primary runway. Note the
birdbath near right edge of runway
